Renovation Synopsis

by Nik Epanchin

As most of the Point Arena Lighthouse Keeper, Inc. (PALKI) membership is probably aware, a major renovation of the Light Station was completed earlier this year. Each of the five Light Station buildings was scheduled for various improvements. A grant of \$1.2 million was obtained from California Cultural and Historical Endowment (CCHE). An additional matching \$300 thousand raised by PALKI yielded about \$1.5 million available for the renovation.

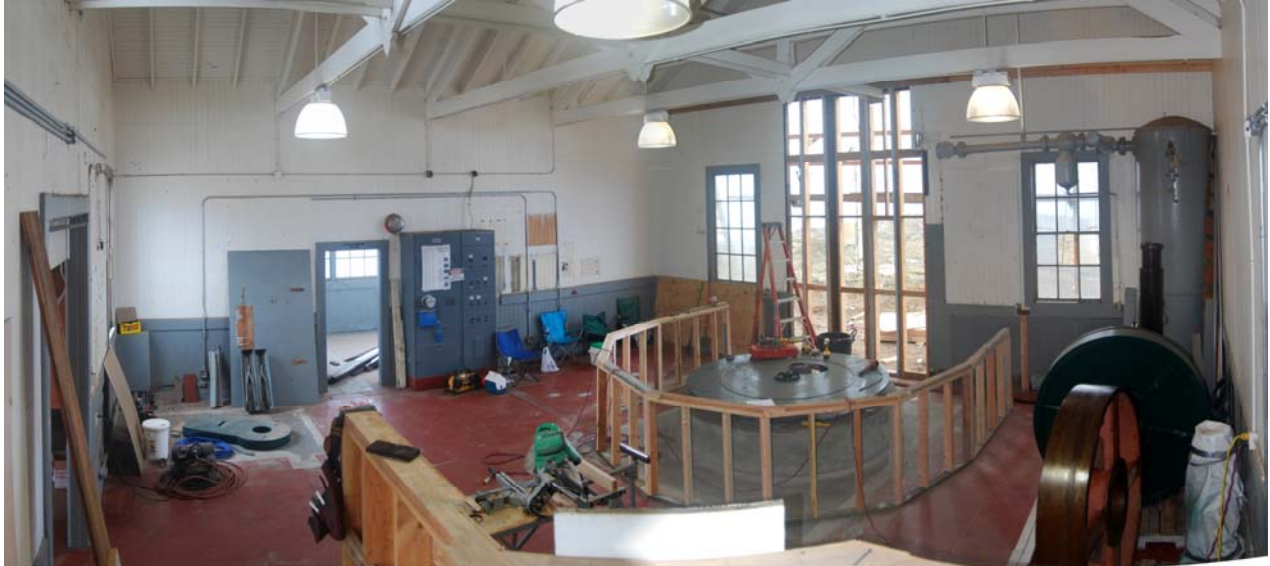
Meanwhile work on the FSB proceeded. Unfortunately it was discovered that the foundation of the whale watch room had severely deteriorated and had to be demolished and rebuilt. A similar problem was found in the office area. As a second thought, rather than storing the once state-of-the-art mercury bath lens drive system as originally planned, it was decided to reassemble it in the FSB museum on a foundation of its own. (The FSB did not have sufficient interior height to reassemble the lens on top of the drive as it had been for the prior 100 years.)

lens and drive foundations, west wall repairs and pony wall installations (Nik Epanchin)

Other FSB work included removal of all museum and gift shop displays, removal of old USCG equipment, pouring a new lens foundation with a pony wall around it, various electrical upgrades, reinforcement of the museum west wall, roof replacement, complete interior and exterior painting, installation of an electronic security and fire alarm system, replacement of the pellet stove and many minor improvements. The gift shop has been remodeled and is fully operational. Museum displays are currently being updated. Jim Woodward's team returned in November 2008 to reassemble the mercury drive and the Fresnel lens.

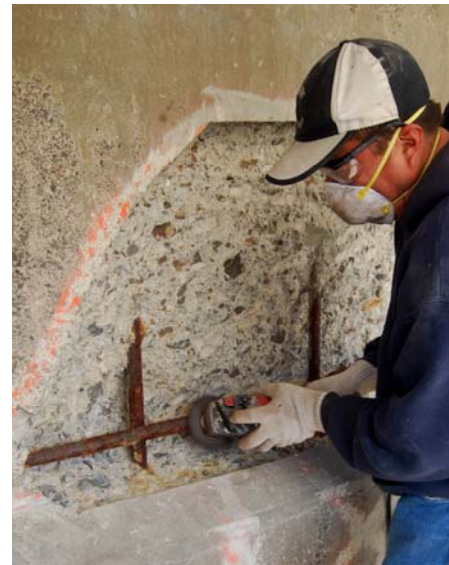
good concrete (concrete with an undisturbed bond to rebar) from concrete which, as result of rust and steel delamination, had suffered separation from the imbedded rebar and required repairs. The results indicated that the extent of damage needing repair was much more extensive than included in the bids. The tower itself was surprisingly free of damage; however the buttress and the entire gallery had substantial damage. (The final repaired square footage was over 5 times the bid square footage. This could not have been predicted without first erecting scaffolding.) Areas needing repairs were identified, their perimeters diamond sawed, the concrete chipped away to expose the rusted rebar, the rebar ground to shining metal (or at times replaced), sacrificial anodes installed, rebar coated, the area formed, grout injected and allowed to cure and the forms stripped.

grinding rebar (Nik Epanchin)

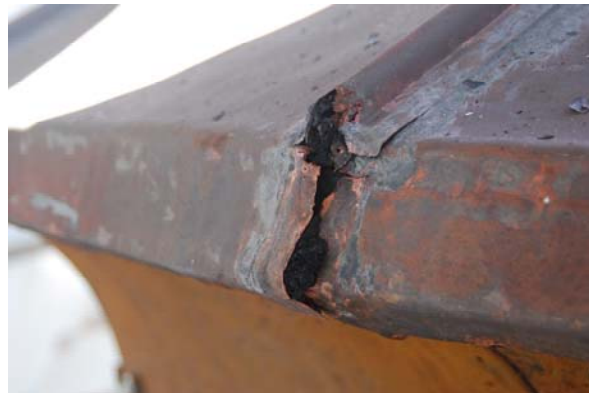
More unexpected damage was discovered after all the plywood lantern perimeter panels were removed. The exterior of the mullions (the vertical structural members supporting the lantern glass and roof) were not only badly pitted but they were out of plumb, making an inadequate seal with the glass panels, thus allowing moisture to infiltrate into the lantern room. It was decided to remove all the glass panels and repair each mullion. The 130 year old lantern copper roof salvaged from the original brick lighthouse presented additional problems. Large gashes were found at most of the exterior corner joints of the 16 roof sections. The center portion of the roof also showed age damage. Water damage was evident on the ceiling of the lantern room. PALKI was not successful in locating a contractor willing to repair and guarantee the repairs of this roof, so it was decided to replace the entire roof with new copper.

typical lighthouse roof damage (Nik Epanchin)

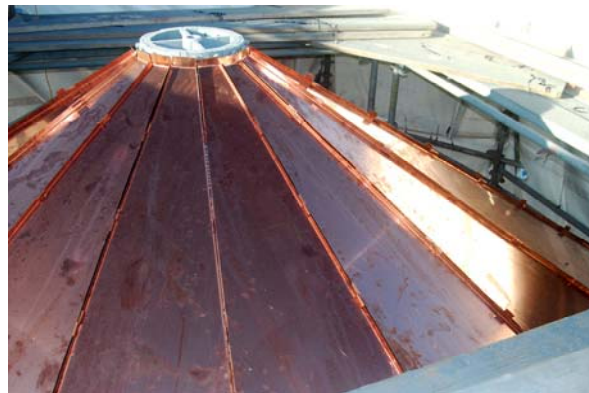
new lighthouse copper roof (Nik Epanchin)
